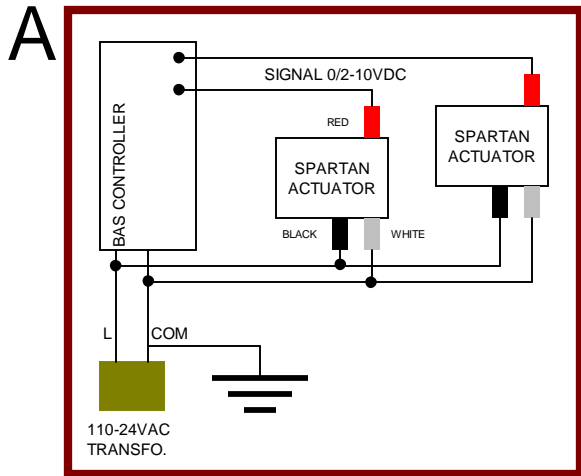
Schematic A is OK

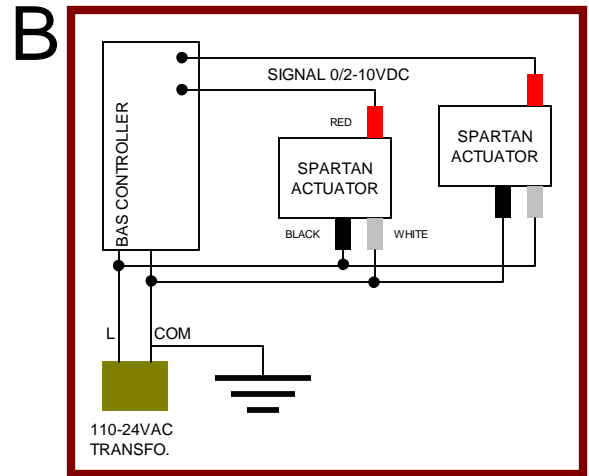
Schematic B is WRONG.

The common ground is inverted on one of the actuator. It could bring erratic positioning of the wrongly wired actuator and also other actuators on the same line.

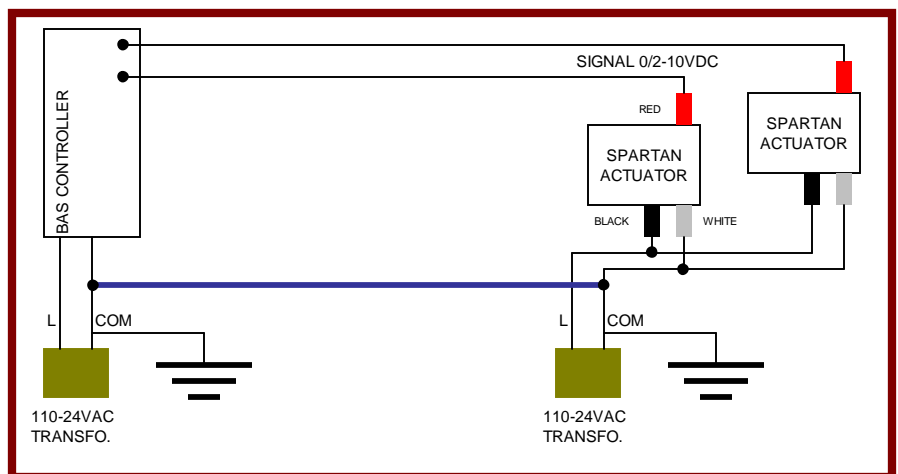
Schematic D is OK.

To bring the ground electrical differential to the same level a hard connection should be made between the common of all electrical transformer. Ground to pipe is not recommended.
